Midwest Energy Association

Leak Investigation

AEGIS Insurance, Loss Control

MEA Leak Investigation

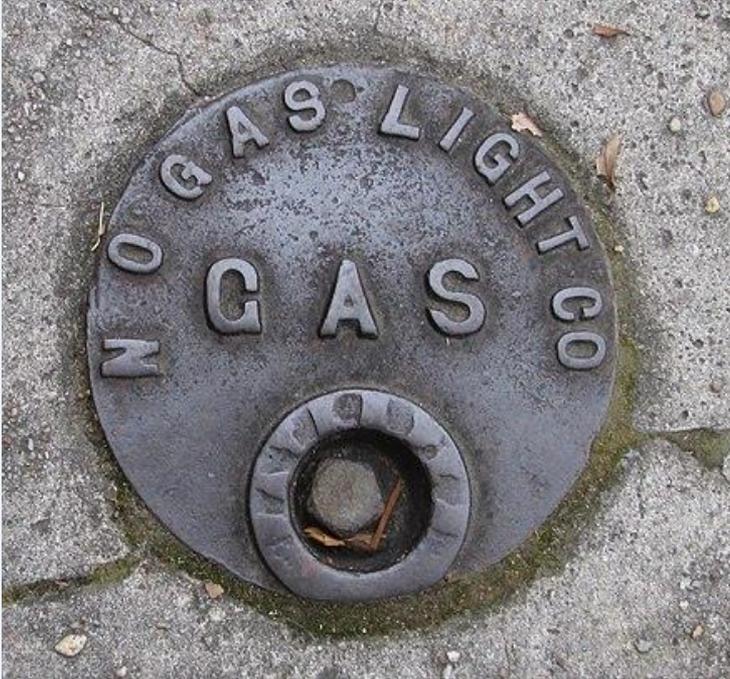
Valve Maintenance

1. Check for Natural Gas Leak.
2. Location/Measurement of Valve.
3. Valve Box Condition.
4. Corrosion
5. Valve Wrench Accessibility.

A fire took place in a 40 unit apartment complex. Although not the original cause the fire was later fueled by the natural gas service. The fire department captain requested that the gas company respond and shut off the service to the building.

A company 1st responder arrived and after 40 minutes located and attempted to shut off the gas valve. The employee was unable to insert the valve key due to valve box misalignment and debris stuck in the valve box. The 1st responder called for a gas crew to dig up the valve and 1.45 hours later the gas line was shut down.

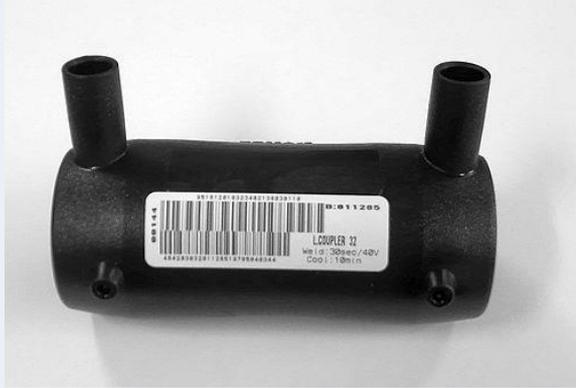
Fusion Steps

1. Clean the Pipe.
2. Scrape the Pipe.
3. Mark the Pipe.
4. Insert the Fitting
5. Clamp the Fitting.
6. Scan the Fitting.
7. Recognize the Correct Fusion Time.
8. Cool Time.
9. Work Time.
10. Backfill.

- The source of the leak was a plastic fusion butt weld that was misaligned.

Although company procedures and initial training addressed fusion misalignment, the companies Annual Qualification did not review these procedures. Subsequently, additional areas where excavated where records showed that the employee made additional butt welds. Qualifications for employees who install and inspect plastic fusions must be followed.

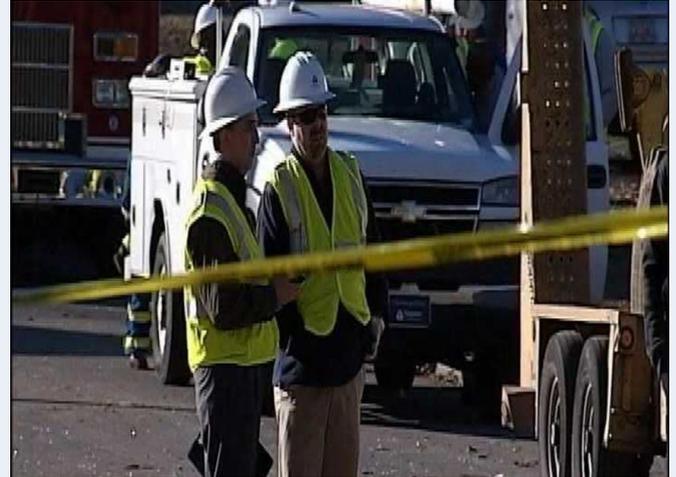
Combustible Gas Indicators

- ❑ Know your Instrument
- ❑ Understand Manufacturers Instructions
- ❑ Calibration
- ❑ Daily checks

- ❑ 25 year Service Technician
- ❑ Established Countless Investigations
- ❑ Evacuations & Red Tags
- ❑ **What are the daily checks you perform each day on your instrument?**
